ASBESTOS-CONTAINING MATERIAL RE-INSPECTION FOR BUILDING 1385 VOLUME 16
CNC CHARLESTON SC
2/15/2000
BAT ASSOCIATES, INC.

**Asbestos-Containing Material Re-inspection
For Building 1385
Charleston Naval Shipyard
Charleston, South Carolina**

Contract No. N2467-96-D-0998
Delivery Order No. 0013

February 15, 2000

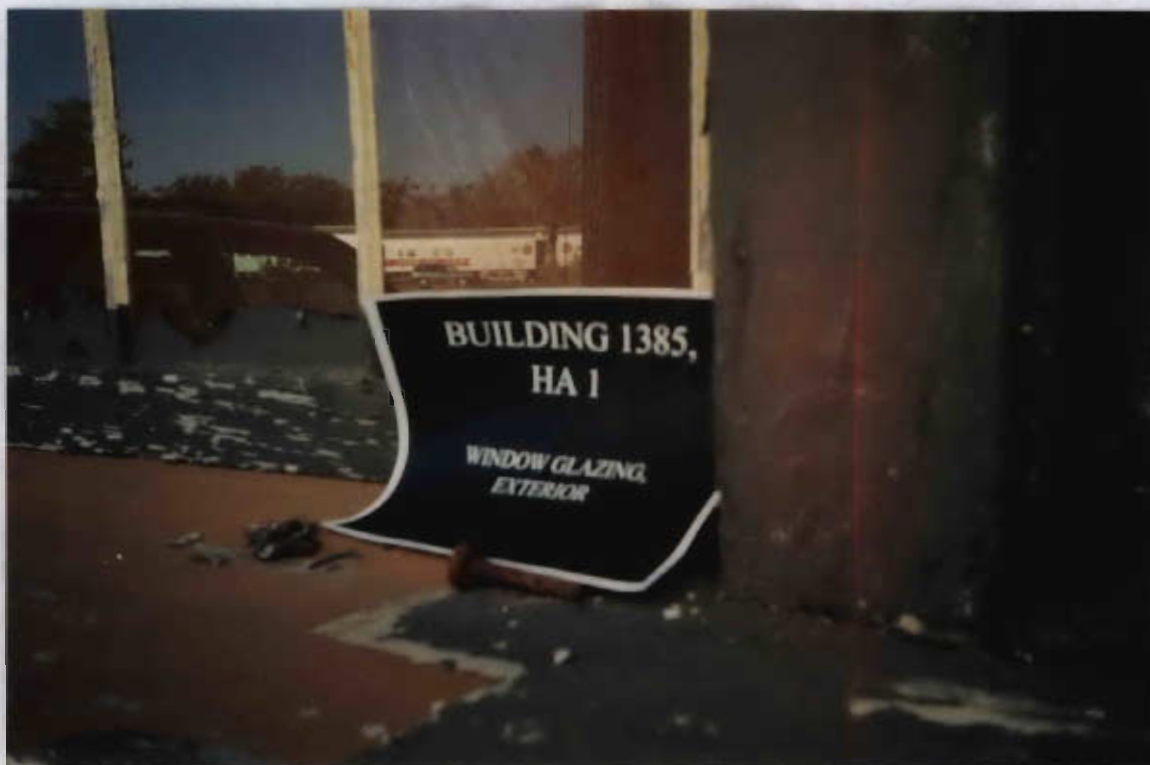
HA No.	Material Description	Sample Analysis Results	Approx. Quantity of ACM	NESHAP Category
1	Window Glazing	Inaccessible, assumed to contain asbestos	110 LF	Regulated, friable

All of the identified and/or assumed asbestos-containing materials observed in this building were in good condition on the day of the survey.

Window Glazing, HA # 1

HA No.	Material Description	Recommended Response Action
1	Window Glazing	Removal prior to demolition
